QUINQUENNIAL INSPECTION REPORT
KINETON BARN

1.00 Description

This is a traditional two storey barn dating from the 19th Century.

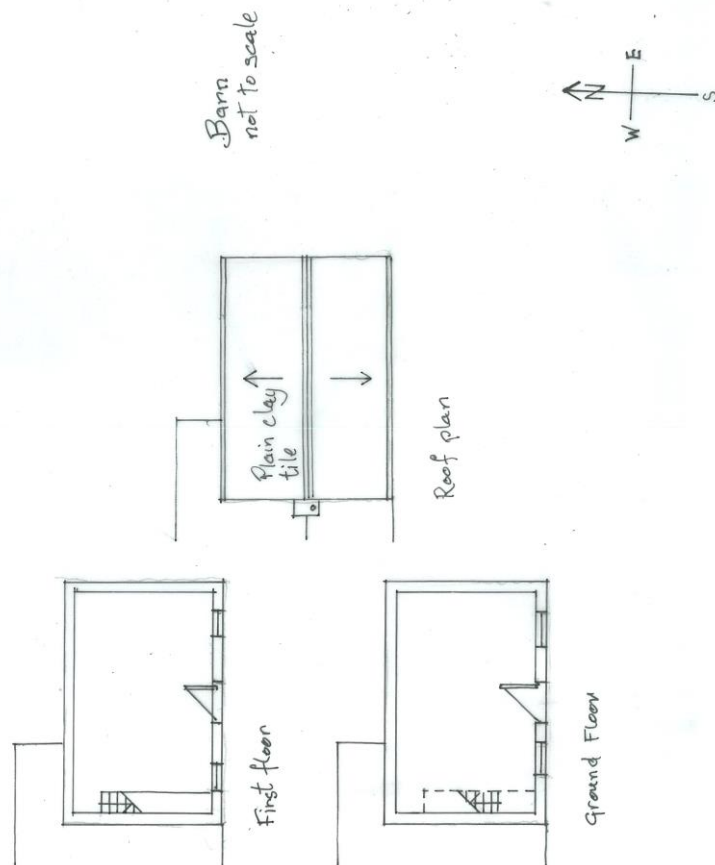
Plan A

First floor of timber. Main beams supported on posts. The joists and boarded floor appear to be relatively modern. Concrete ground floor. There is a narrow stair against the west wall (**Figs 1 & 2 & Plan A**)

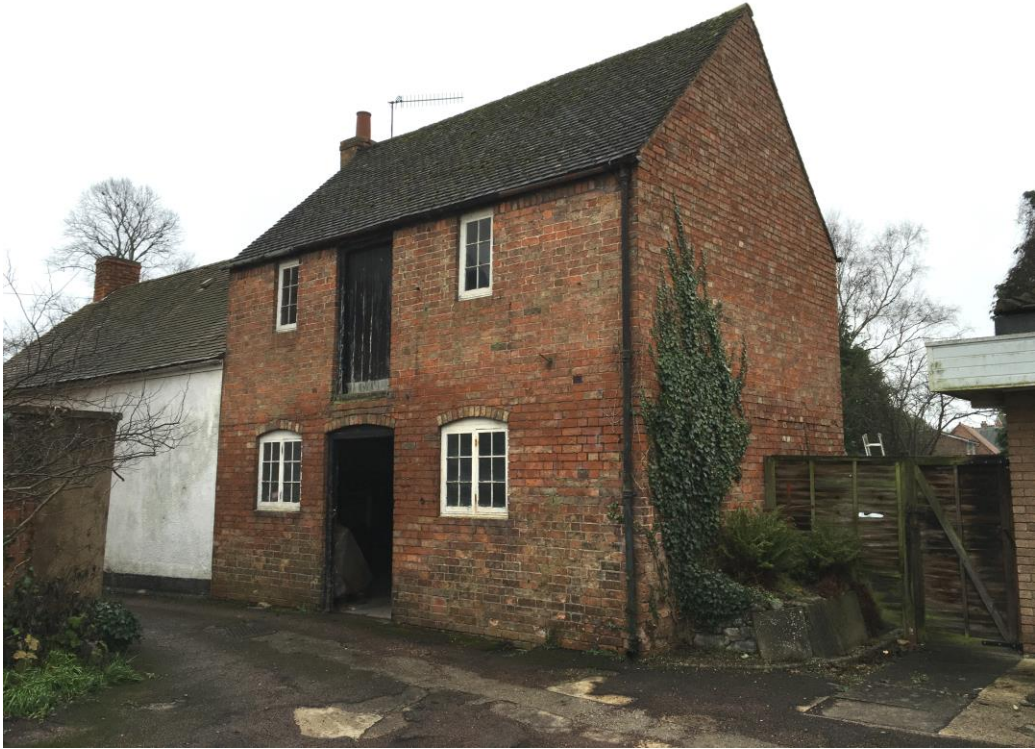
Fig. 1

3.02 South Elevation (*fig. 1*)

Open joints to brickwork particularly adjacent to the downpipe which is rusting, possibly leaks from the joints. Decorations and puttying failing to window. Weatherboard at the base of the first floor door and the ground floor door are missing. Cill of the first floor door rotting. Eaves gutter rusting. Open joints below the first floor doorway. Rusted eaves gutter.

Timber work and glazing would benefit from repair and redecoration and the replacement of missing weatherboards.

Replace missing weatherboards to doors.

Redecorate timber, doors, windows and door frames, replacing any rotted wood.

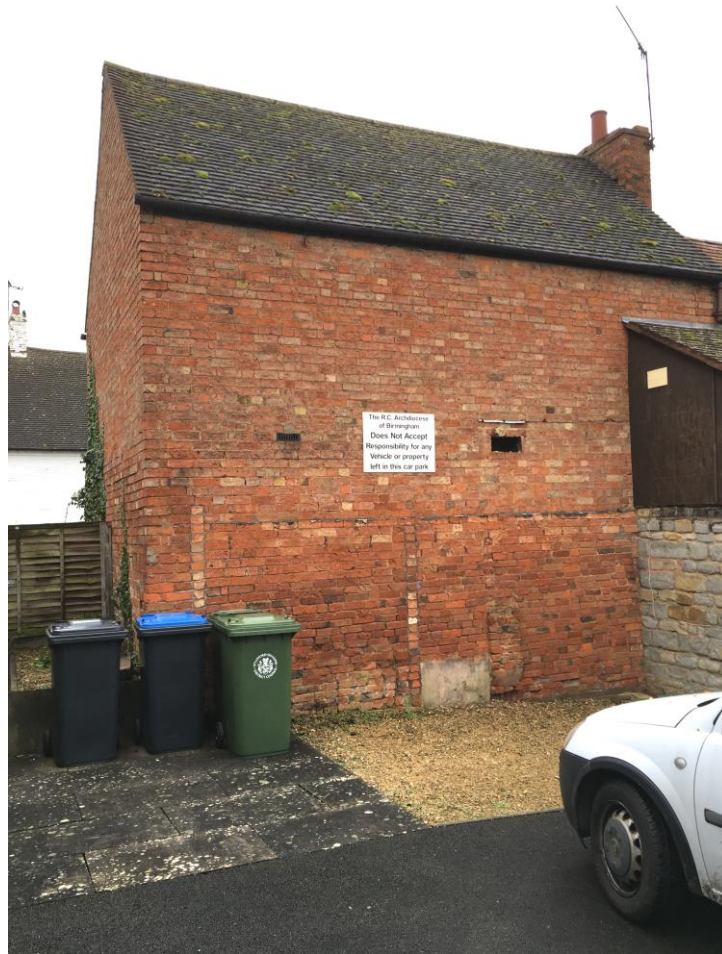
Fig. 2

3.04 North Elevation (*fig. 2*)

Open joints to brickwork particularly at low level. Generally in sound condition.

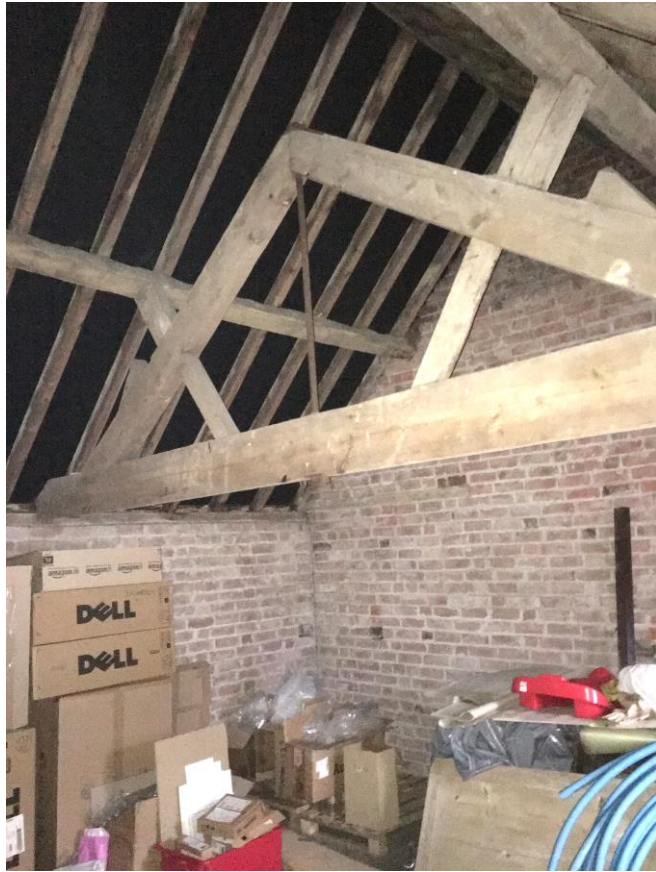
Fig. 3

Floor – Timber floor generally in sound condition (**Fig. 3**).

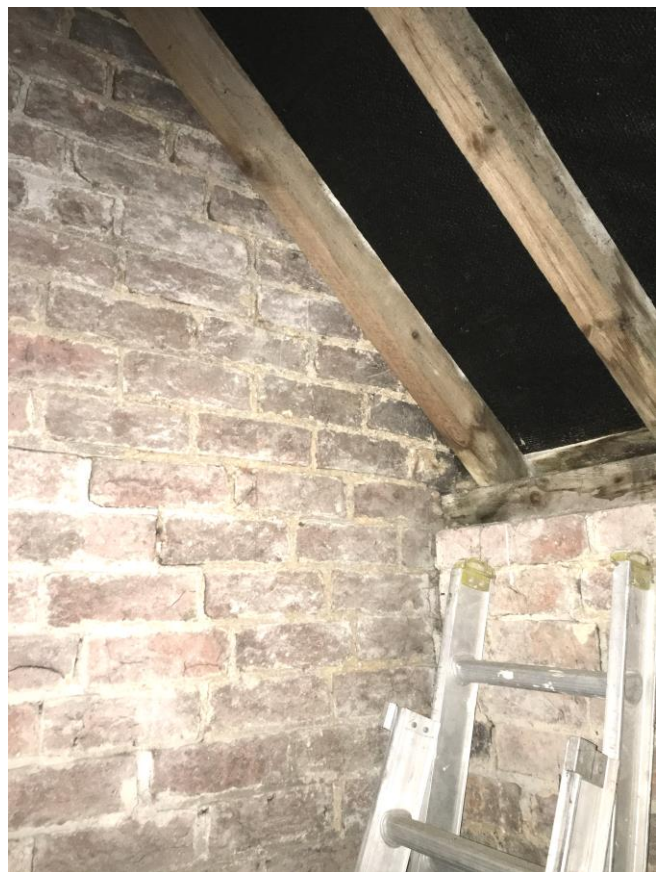
Fig. 4

Two splendid traditional wooden trusses supporting purlins. Roof is relatively modern it is felted and in good condition. North wall is not bonded into the south wall (**Fig. 4**). There is slight movement at the top of the north wall and a crack runs from here diagonally up to the purlin. Some dust to a rafter which may indicate wood-boring beetle though I think this is minor as roof timbers are modern. Minor crack through joints towards the east end of this north wall (**Fig. 5**).

There is some structural movement particularly where this is poor bonding between walls. This could be addressed by introducing stainless steel ties into the joints of the brickwork.

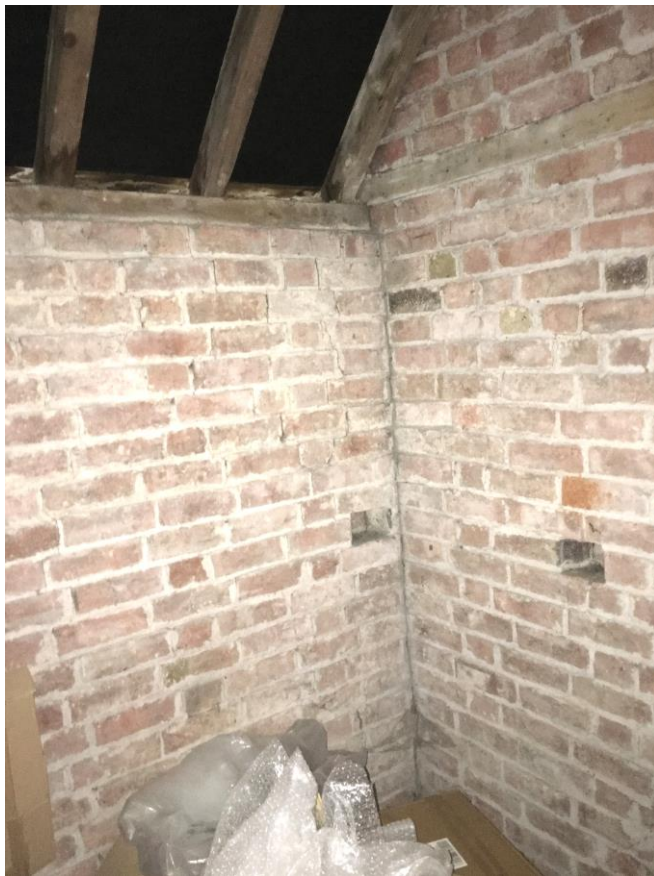
Fig. 6

The east wall is generally in good condition. Slight cracking at the junction of north and east wall (**Fig. 6**). Of no immediate worry but this should be monitored. The window timber is not decorated.

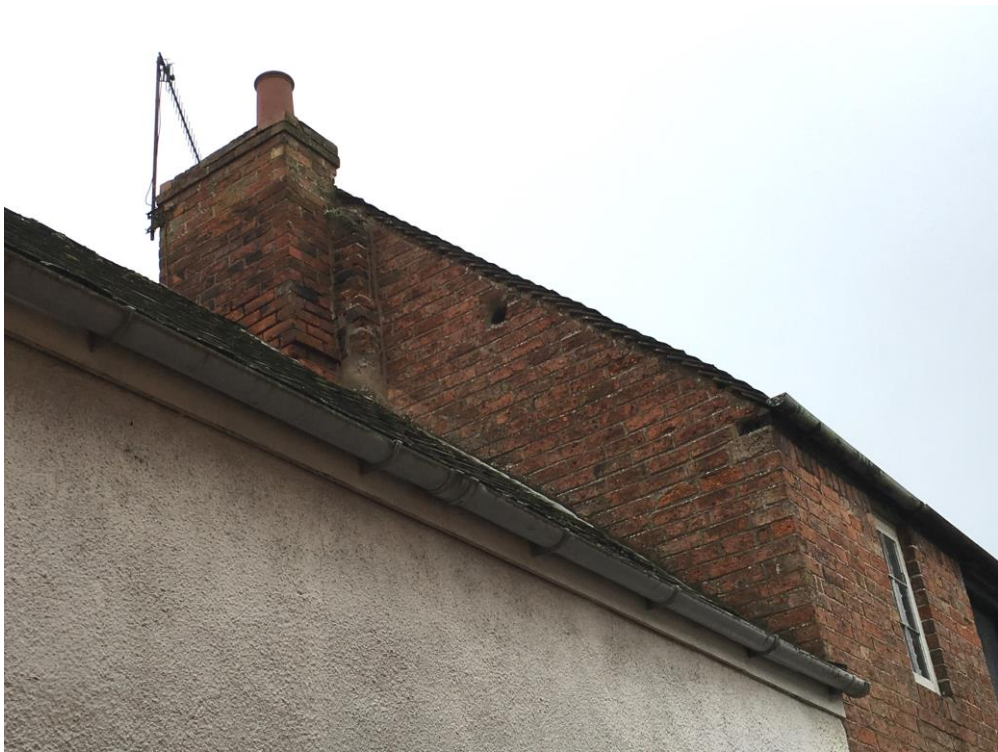
Fig. 7

3.03 West Elevation (*Above the Cottage*) (*Fig. 7*)

Open joints to the abutting brick stack, which serves the cottage rather than to the barn.

Generally in good condition. Open joints and slightly displaced brick at the head of the chimney stack to the cottage (*fig. 7*).
